TIMBER LAKE DAM

CAMPBELL COUNTY, VIRGINIA

VA. NO. 03102

# PHASE I INSPECTION REPORT

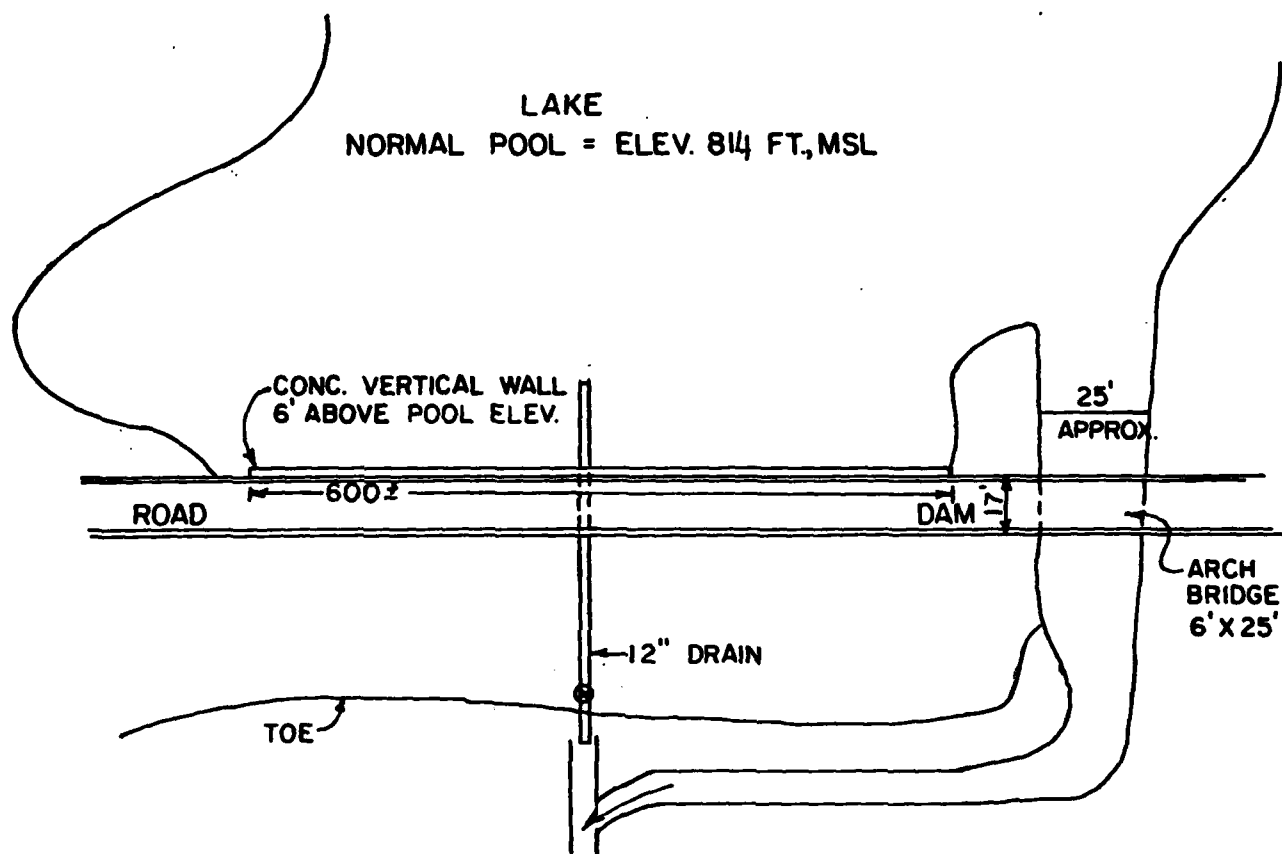
FIELD SKETCH  
PLATE NO. 2

The principal spillway consists of a 6 ft high x 25 ft wide reinforced concrete arch bridge with a bottom elevation of 814 msl. The arch bridge is located at the left abutment and is connected to the lake by a 25 ft wide approach channel. A 12 inch diameter drain located at the center of the dam is used to drain the lake (See Plate No. 2, Appendix I).
